TEMPERATURE AND PRESSURE PROFILES OBTAINED DURING BURN OF A SIDEWINDER MARK 17 MOD 5 MOTOR IN A 15,300 CUBIC-FOOT MAGAZINE

DL Technical Report No. TR-3139
September 1974

ABSTRACT

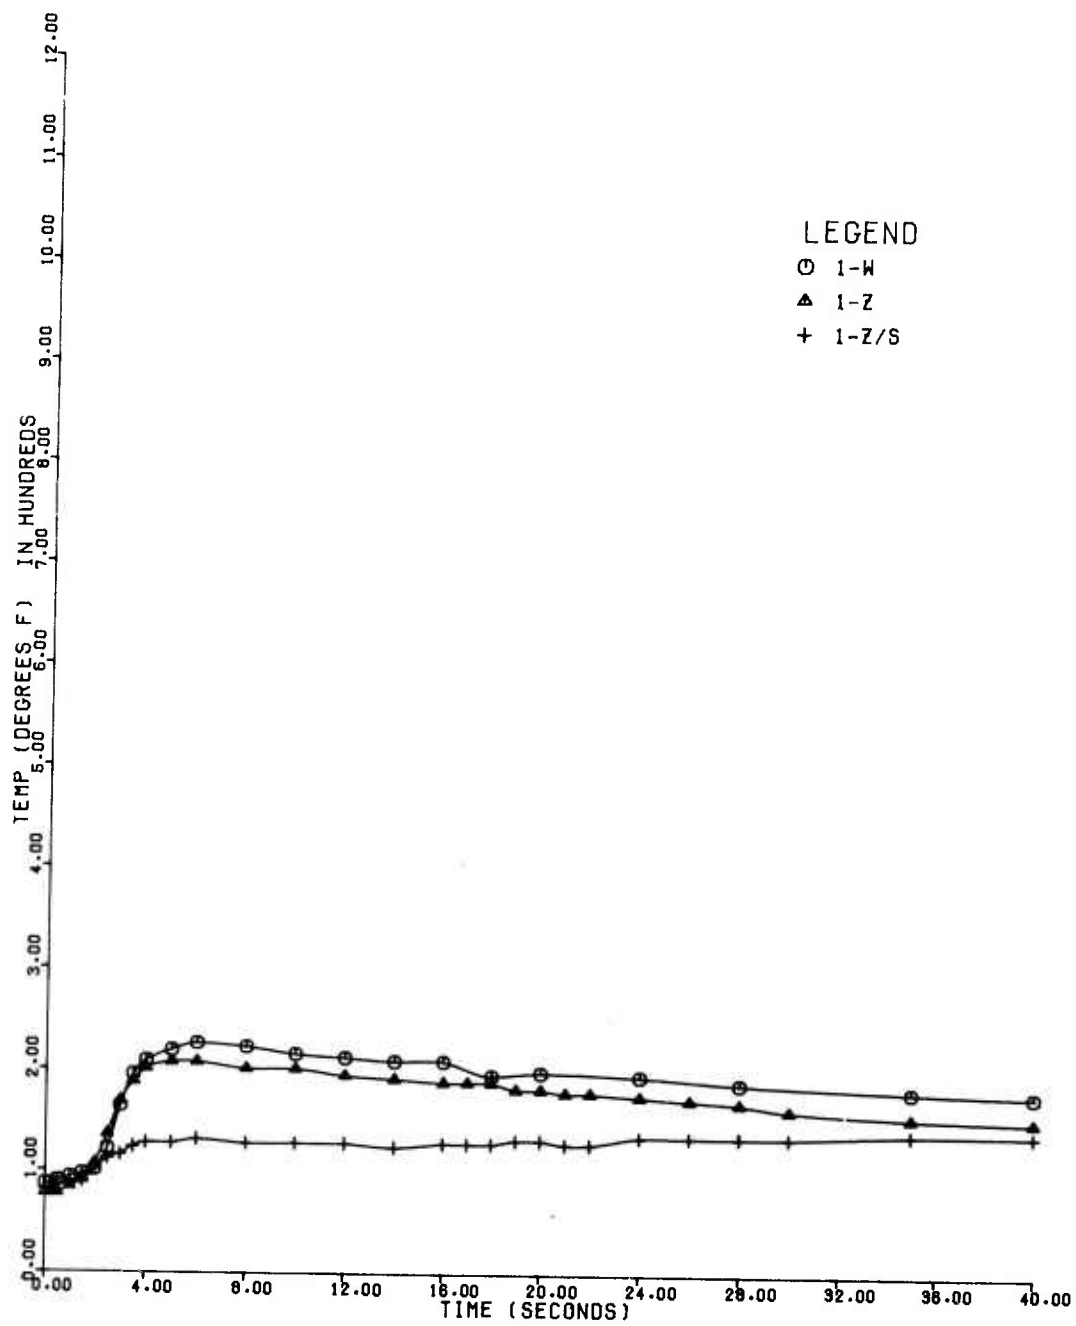
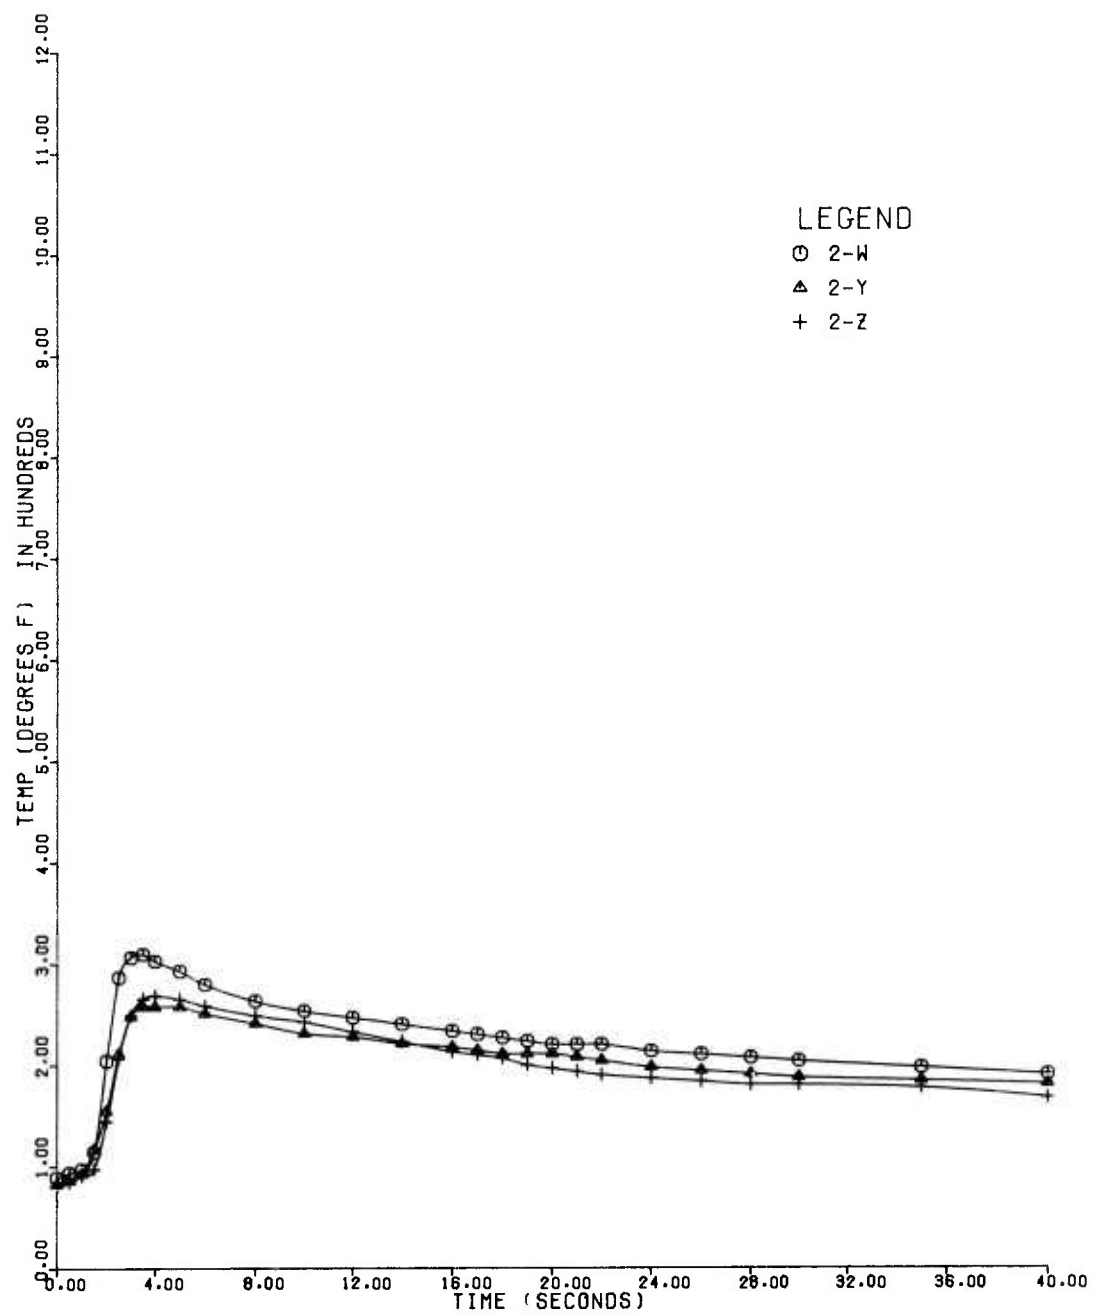
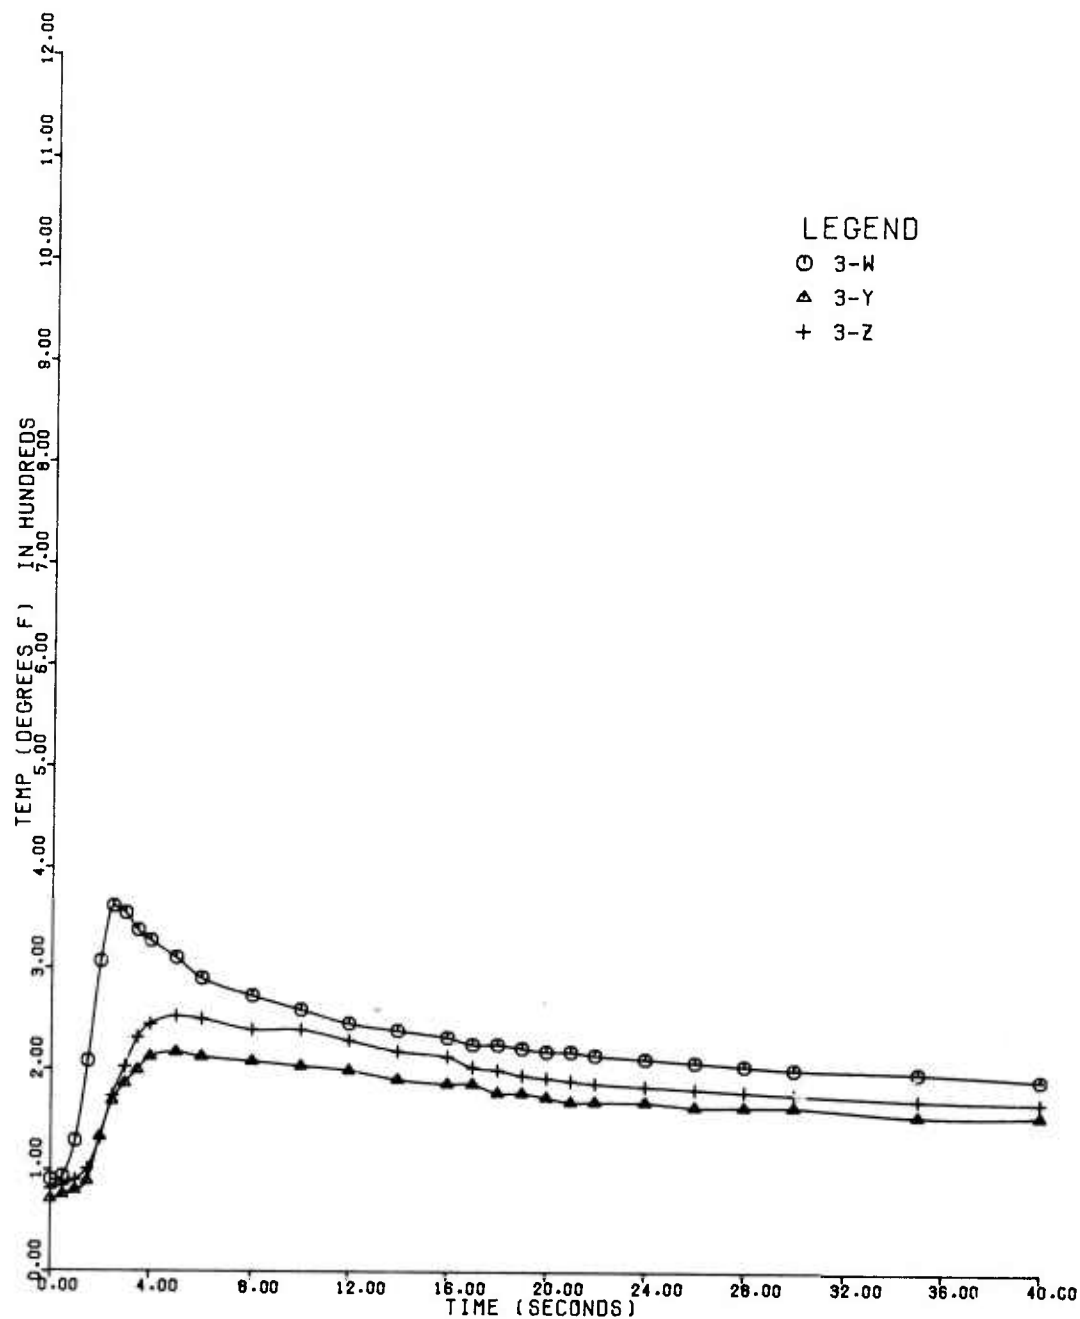
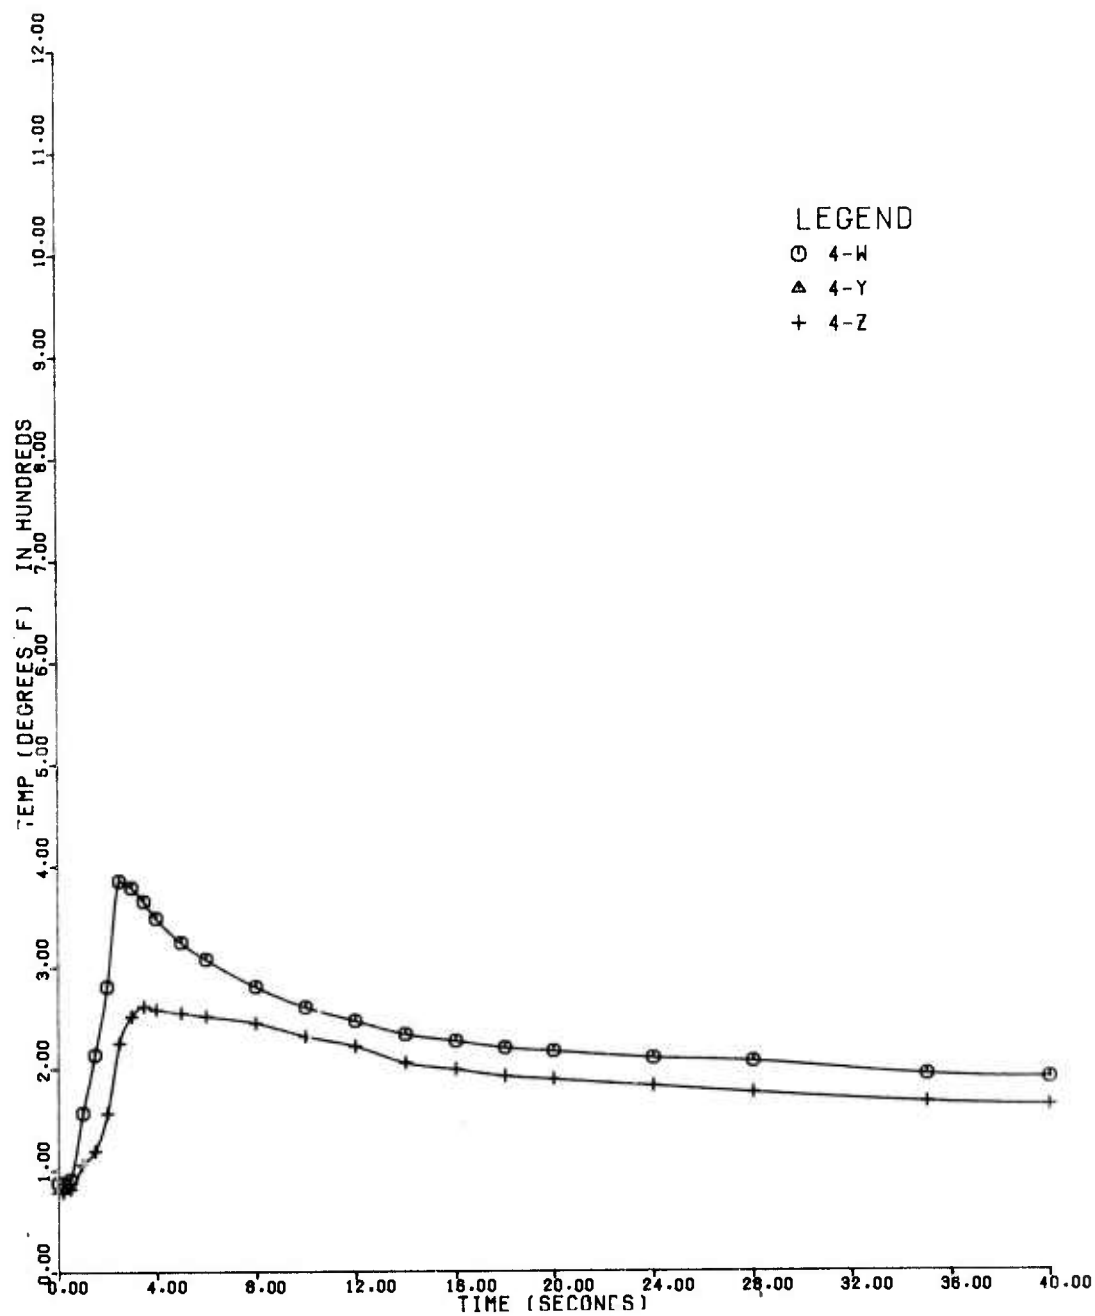
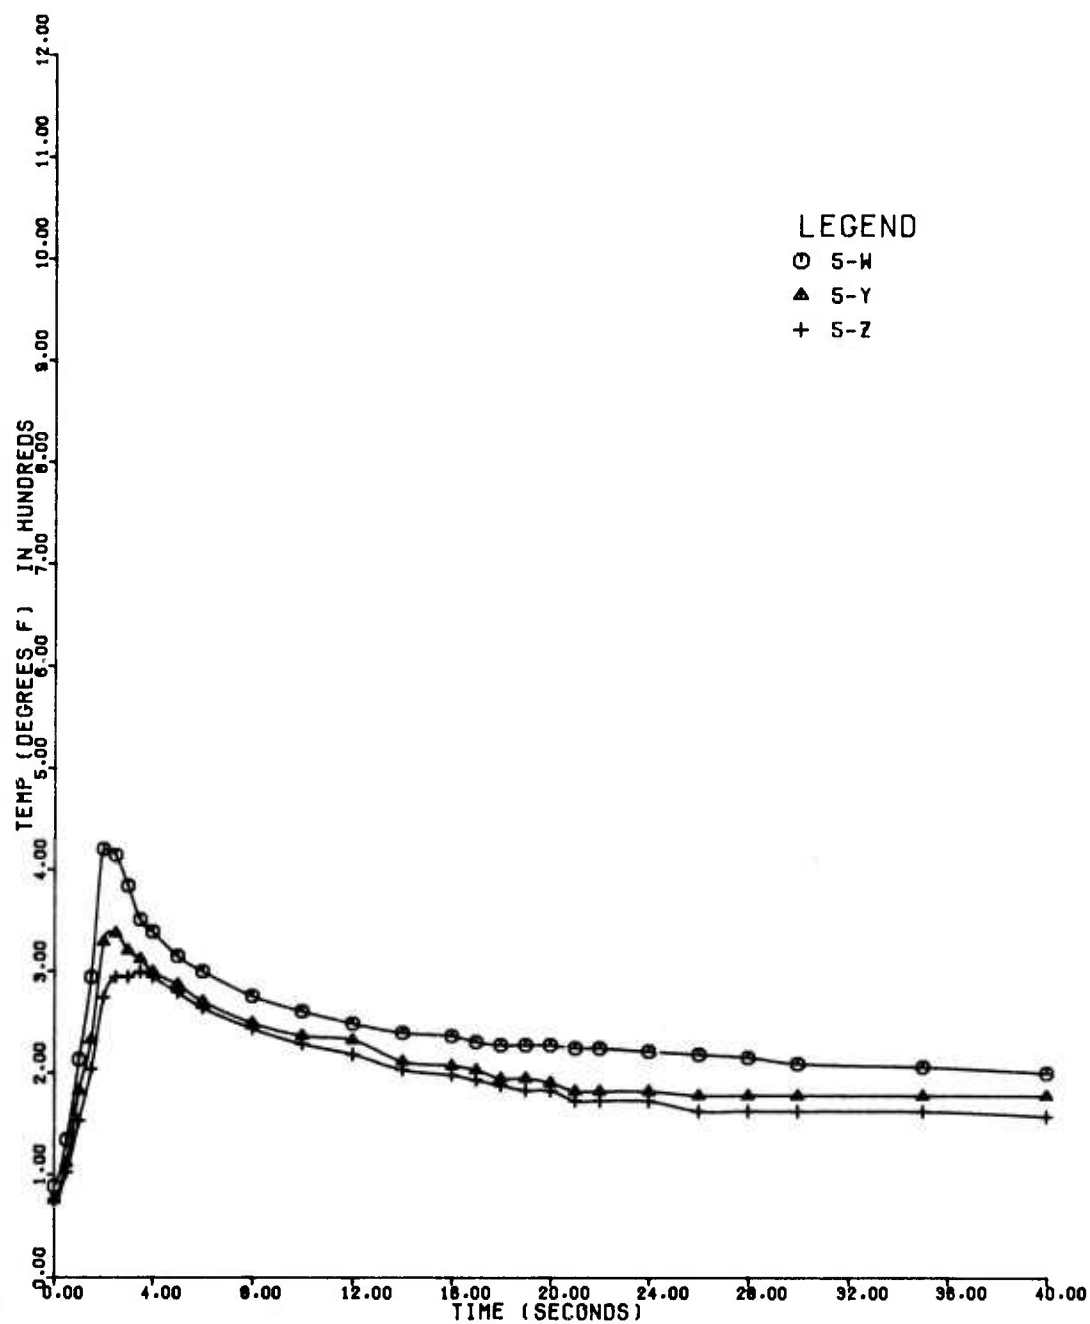
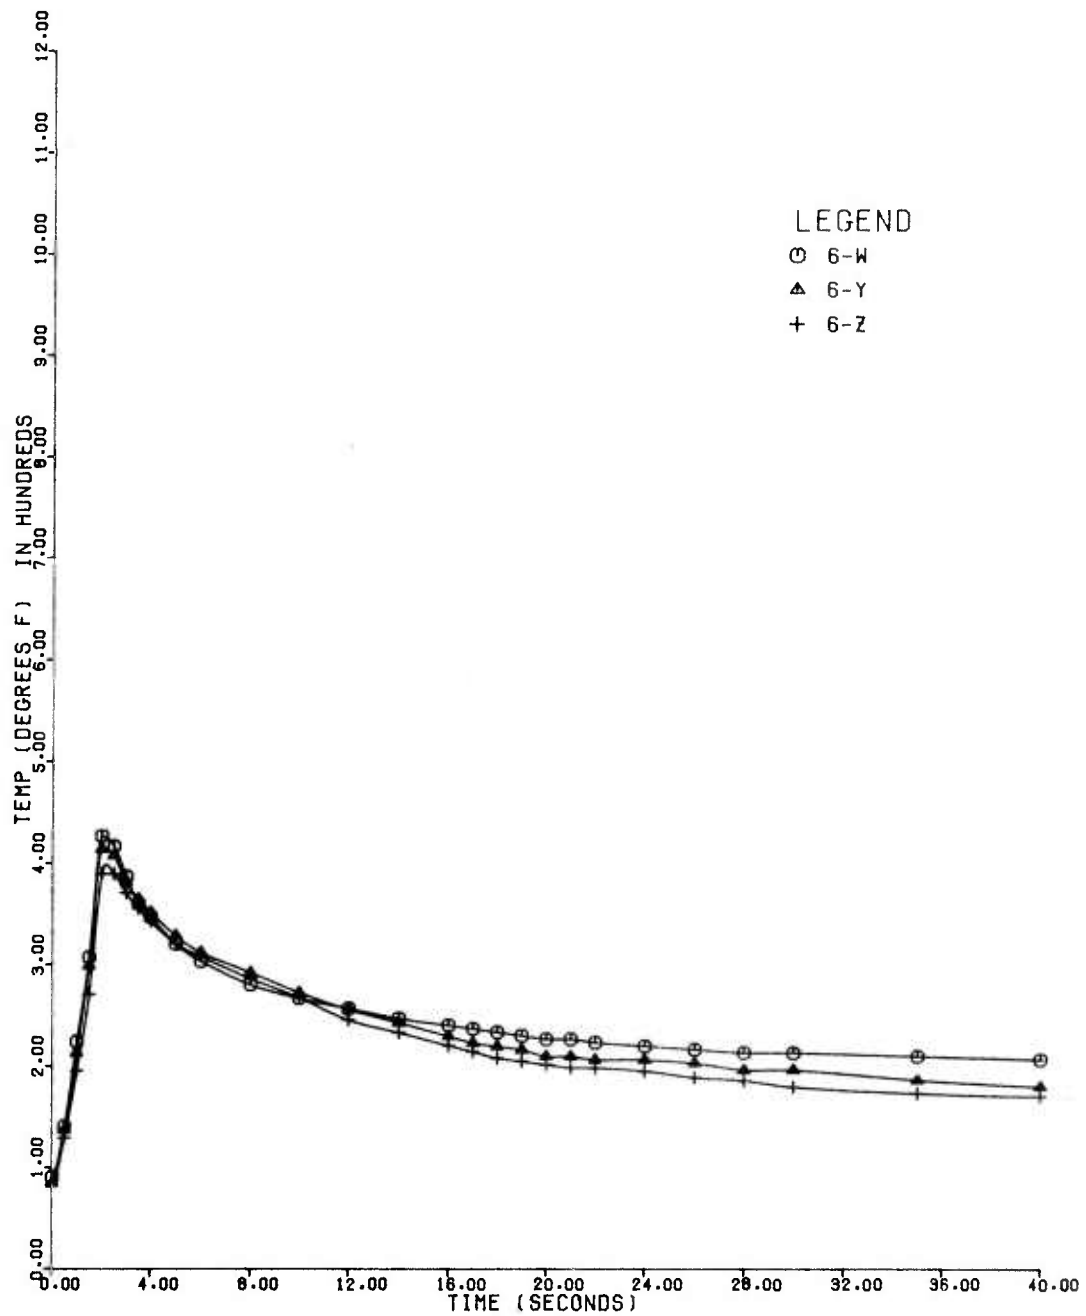
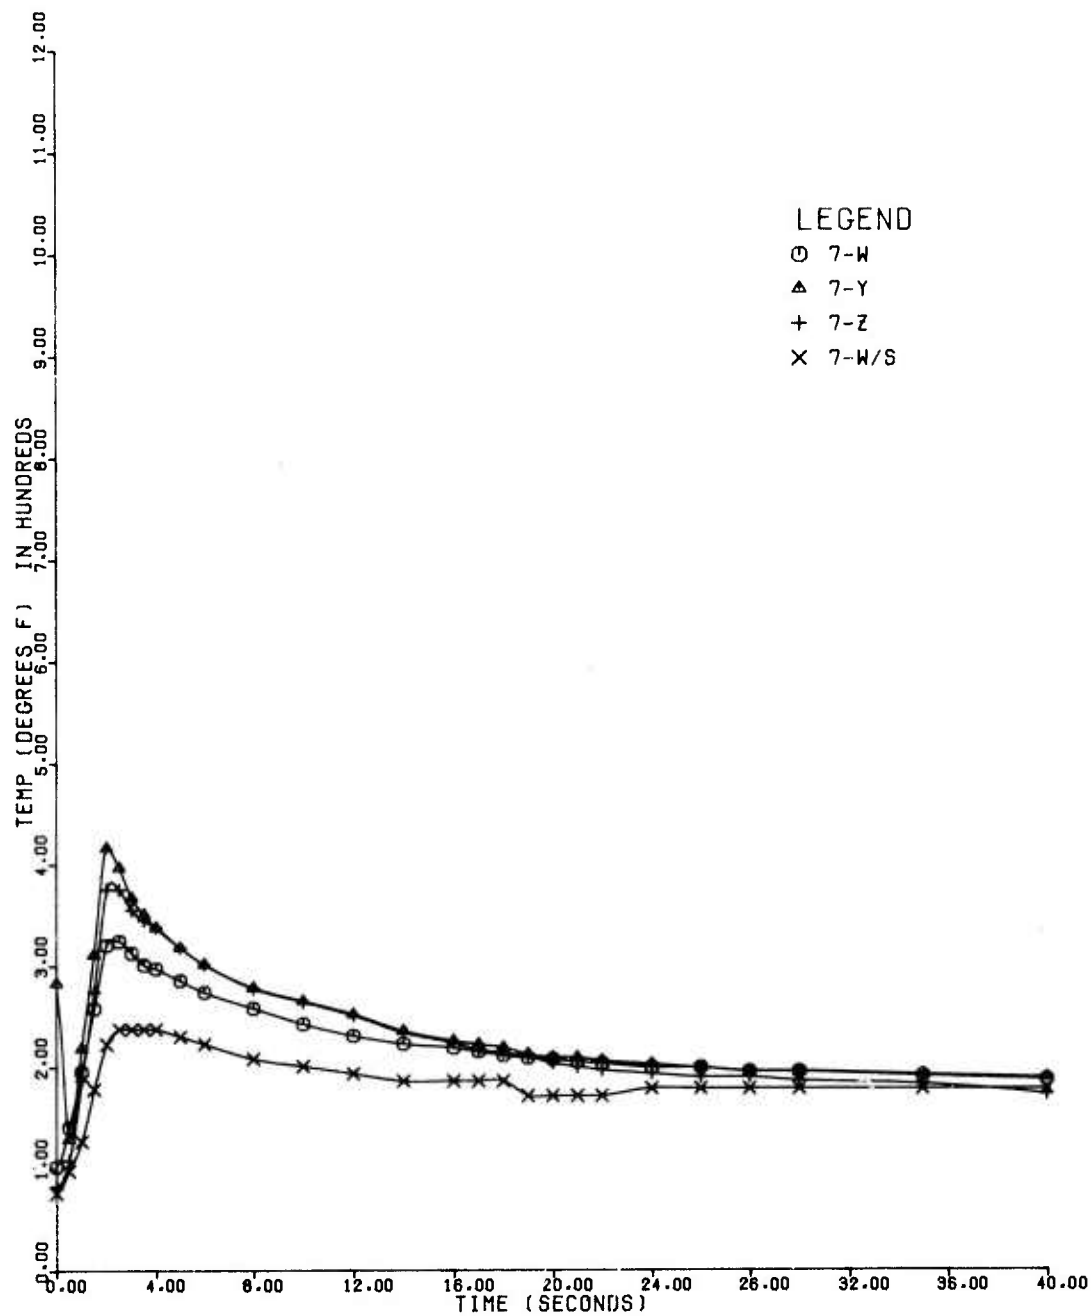
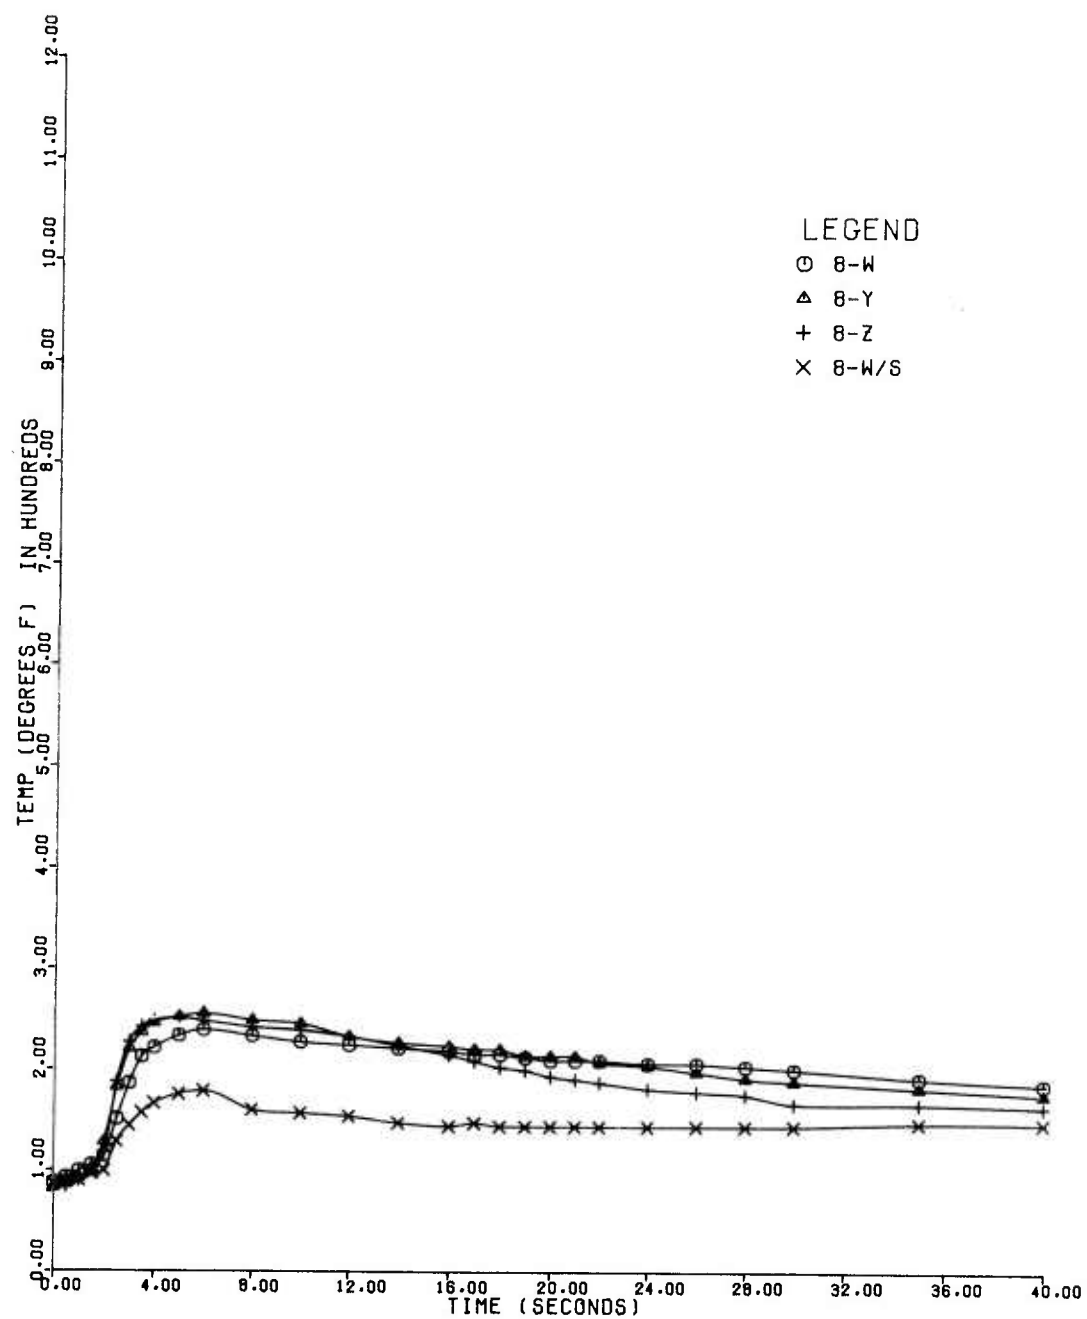
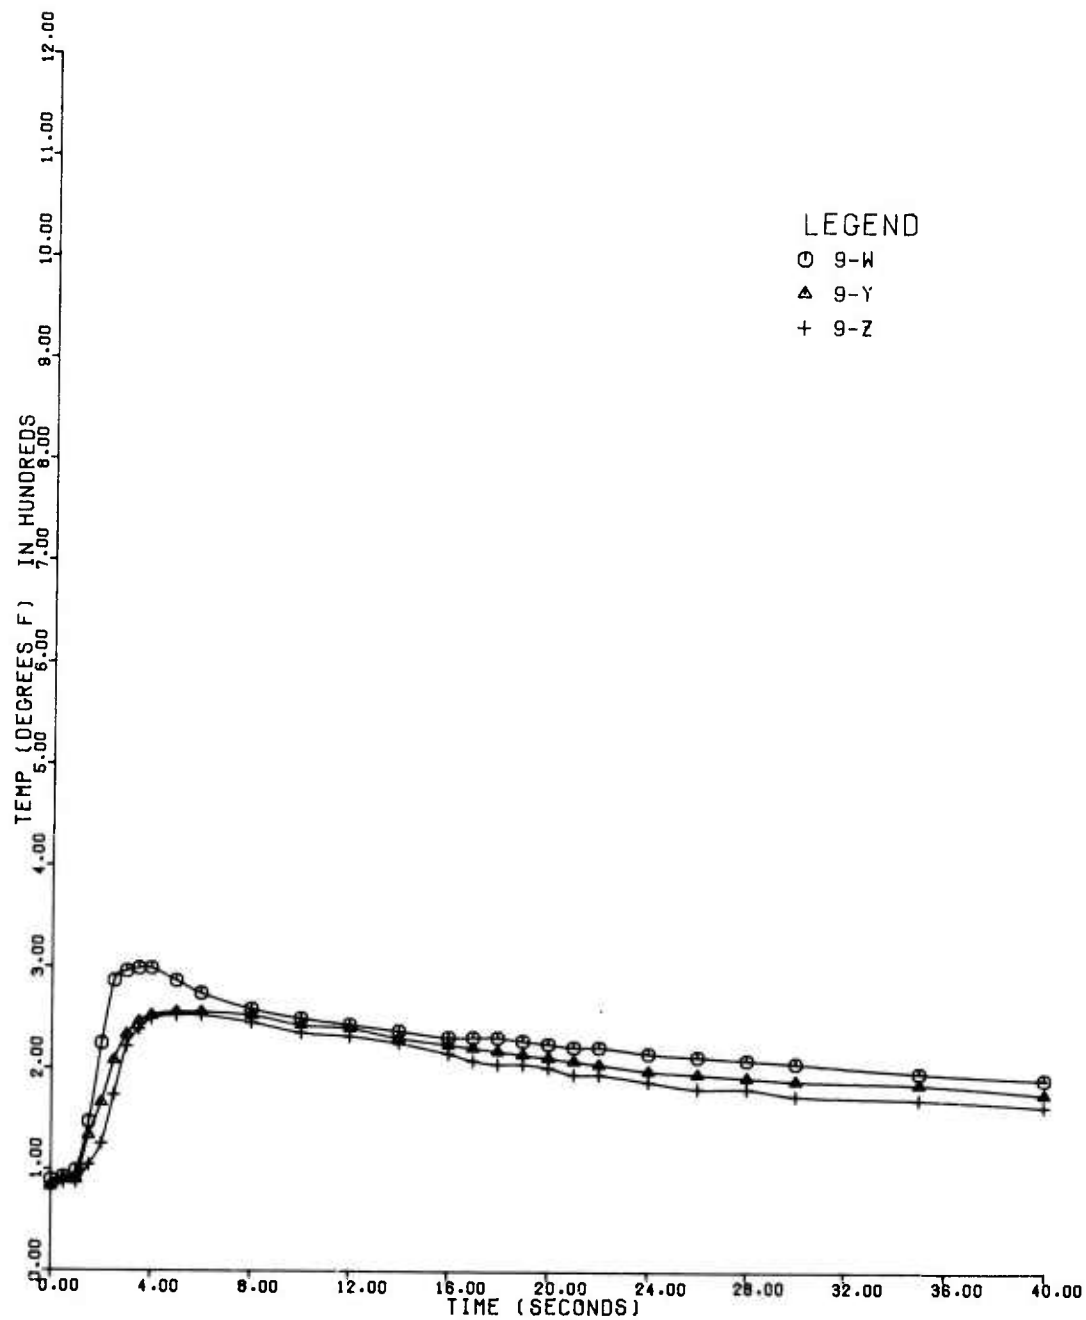
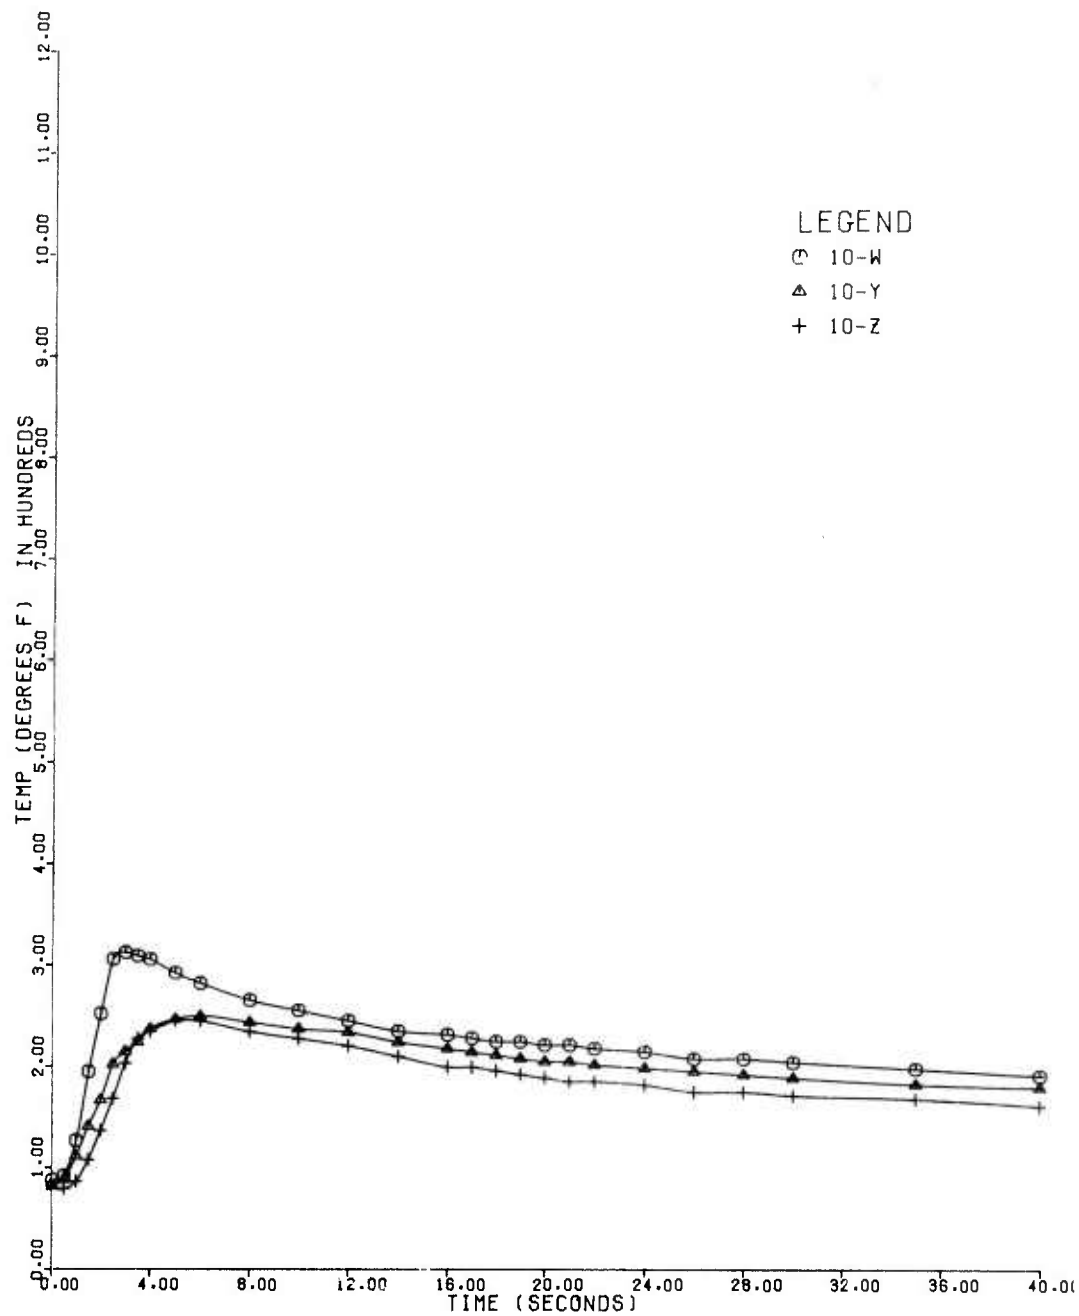
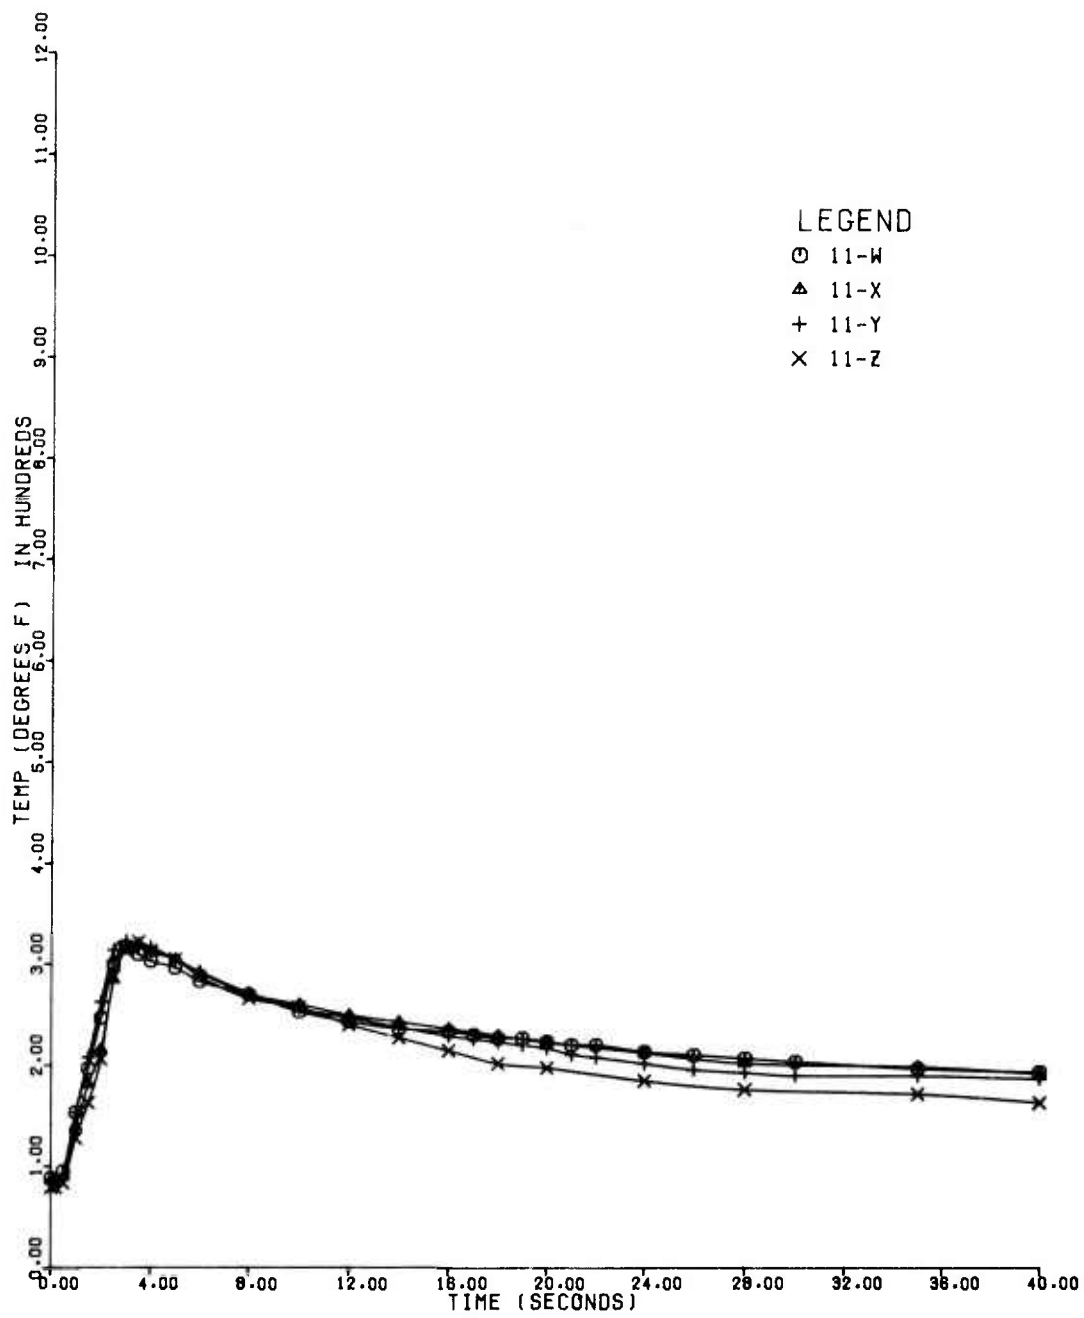
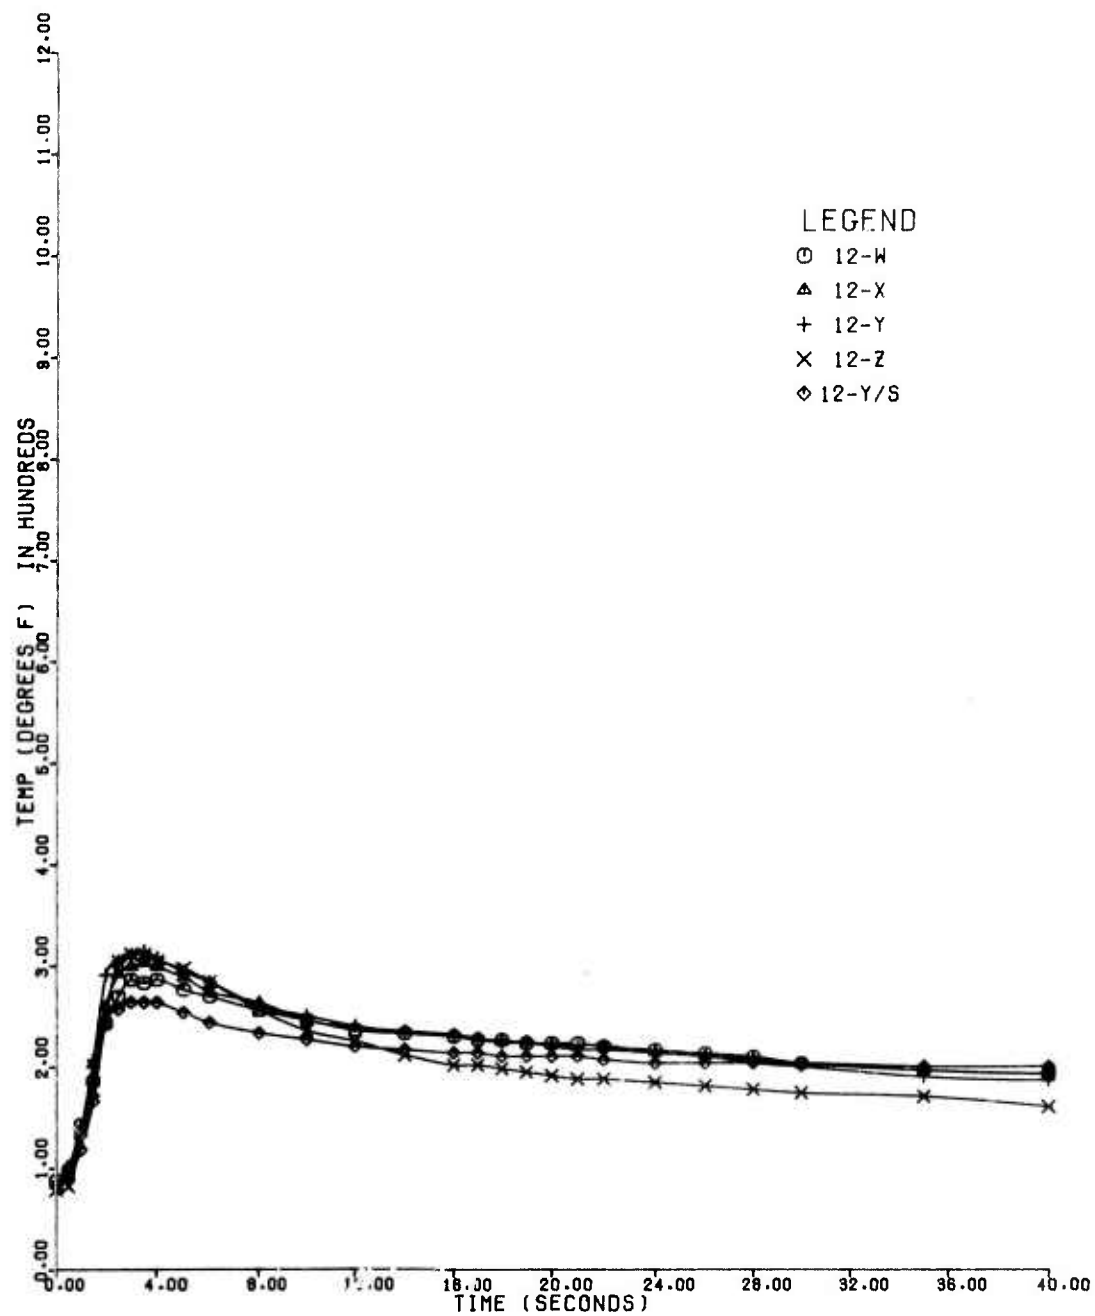
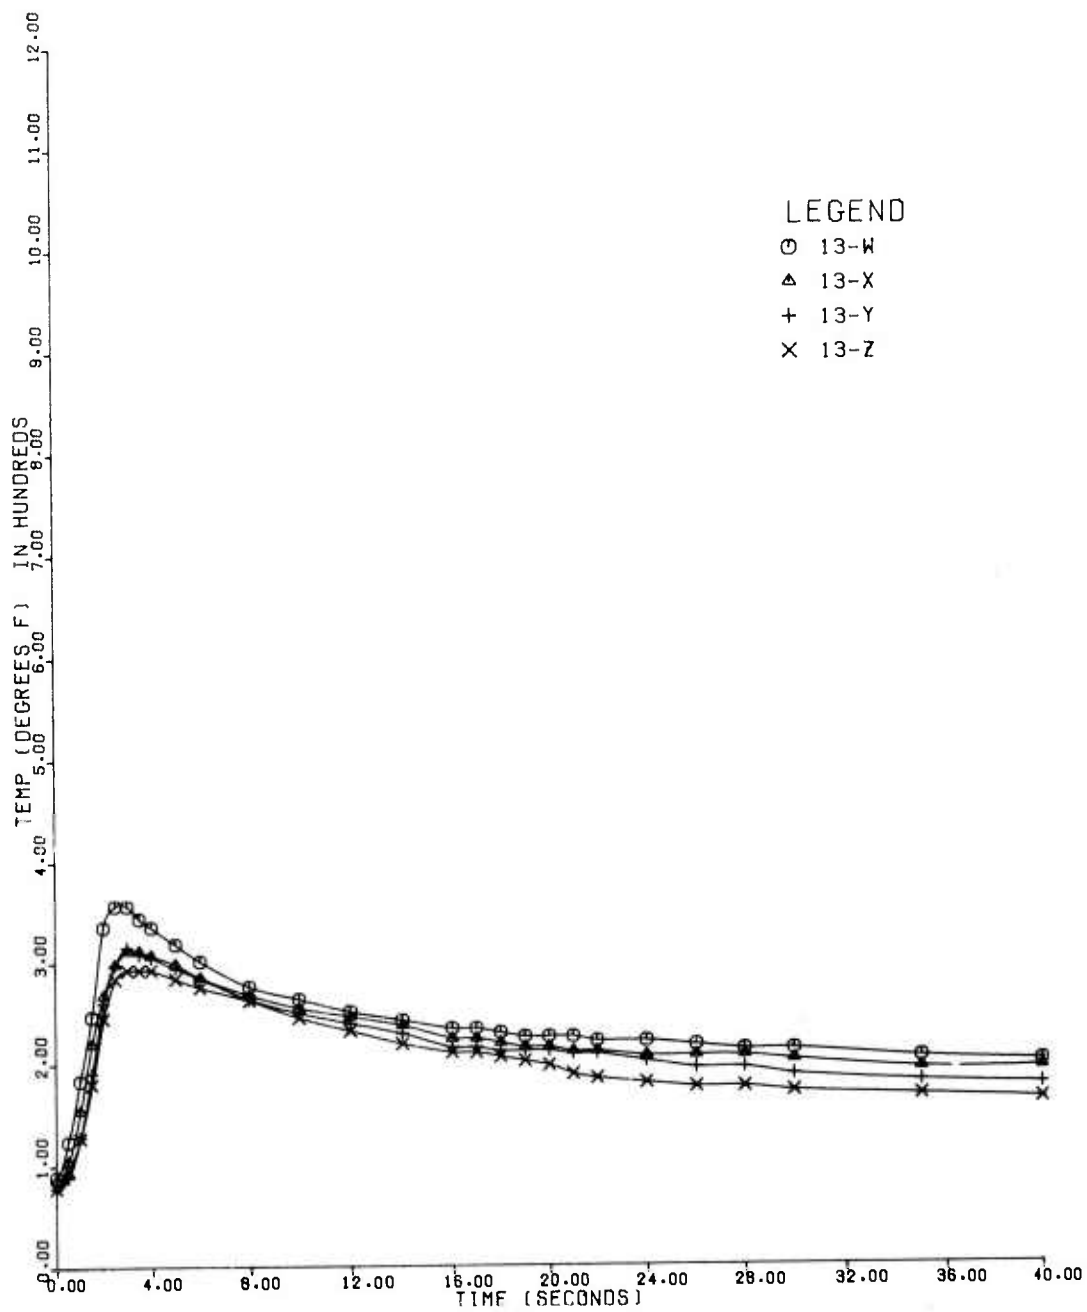
(3) A detailed temperature profile of the test magazine (interior) is shown in Figures 6 through 27 of Appendix E.

1. It is evident from the magazine thermal and pressure data (shown in Figures 6 through 27 in Appendices B, and E) obtained during burn of a SIDEWINDER MK 17 MOD 5 rocket motor in Tests Nos. 1 and 2, that the magazine thermal environment was not as severe as expected or desired. Because of these low temperature and pressure profiles, a SPARROW MK 38 motor was used as the active motor in follow-on tests.
